Inspection Report

Property Address:
4206 W 59th Street
Fairway KS 66205

CC Home Inspection LLC

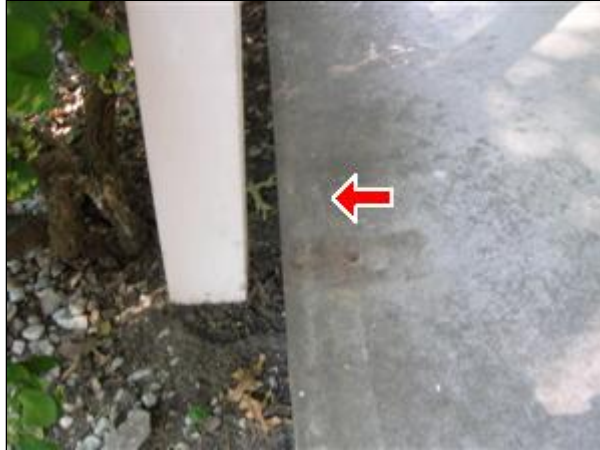
1.2 Picture 1

🔧 1.2 The front porch has settlement that should be serviced by a qualified contractor. The porch has settled and the support posts are loose at this time.

The front porch has settlement that should be serviced by a qualified contractor. The porch has settled and the support posts are loose at this time.

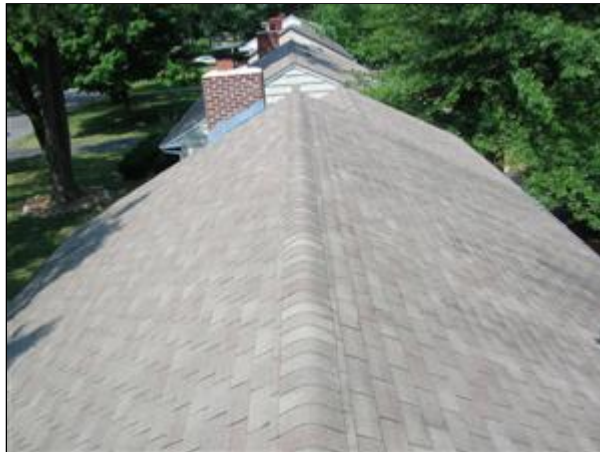
1.5 Picture 1

1.5 The roof appears to have three layers of roofing material. The next time the roof is replaced, it will need to have layers removed.

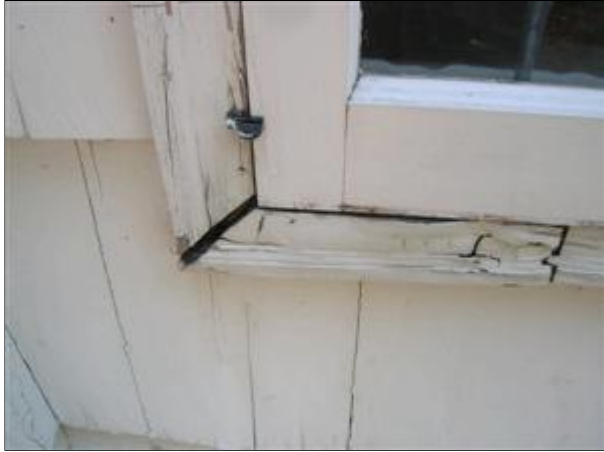
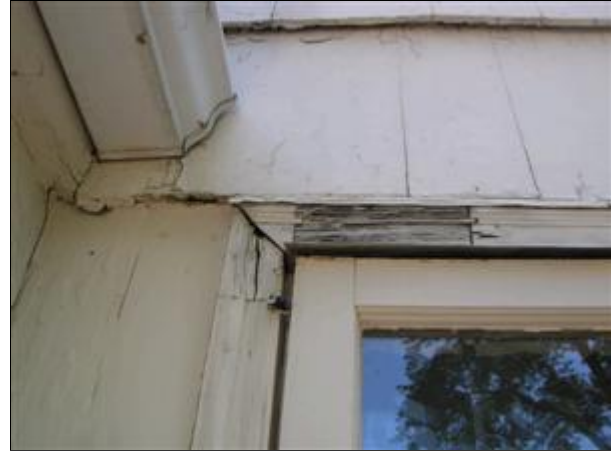
2.2 Picture 1

🔧 **2.2** The window frame deteriorated at front of home. Further deterioration may occur if not repaired. A qualified contractor should inspect and repair as needed.

The window frame deteriorated at front of home. Further deterioration may occur if not repaired. A qualified contractor should inspect and repair as needed.

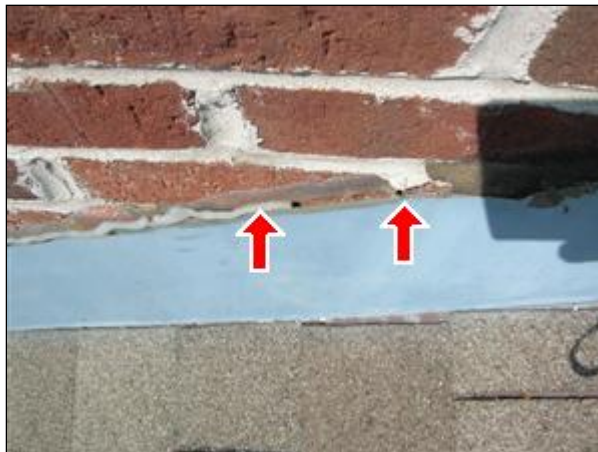
3.1 Picture 1

**3.1** The chimney flashing need to be properly sealed by a qualified roofing contractor to prevent moisture infiltration.

The chimney flashing need to be properly sealed by a qualified roofing contractor to prevent moisture infiltration.

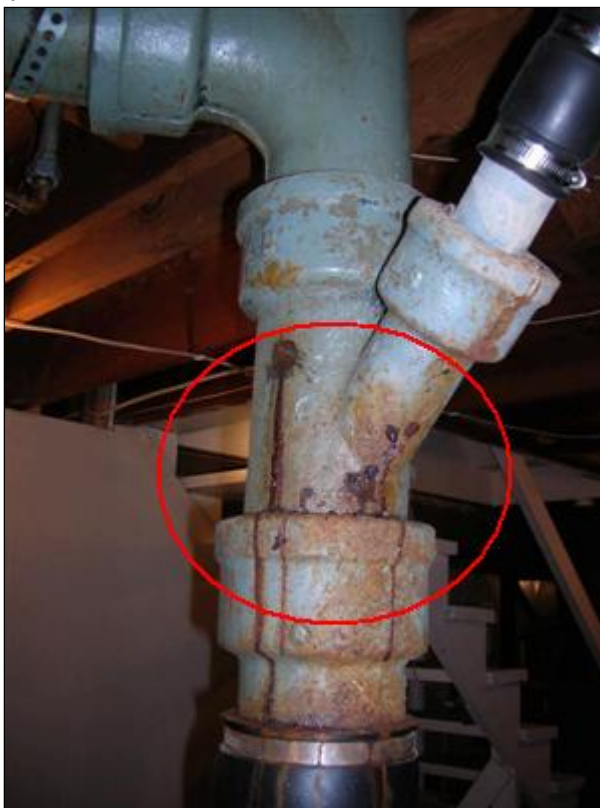
4.0 Picture 1

🔧 4.0 (1) The plumbing waste line rusted and deteriorated below bathroom in the basement. Repairs are needed. A qualified licensed plumber should repair or correct as needed.

(1) The plumbing waste line rusted and deteriorated below bathroom in the basement. Repairs are needed. A qualified licensed plumber should repair or correct as needed.

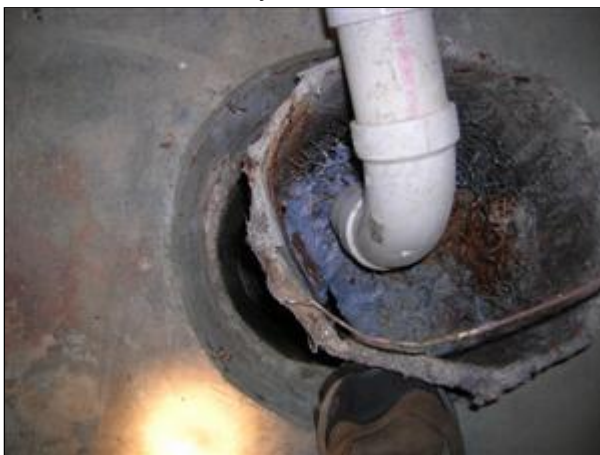
4.0 Picture 2

🔍 (2) The laundry appears to drain to the storm sewer system and should be evaluated by a qualified plumber.

- 🔍 (2) The laundry appears to drain to the storm sewer system and should be evaluated by a qualified plumber.

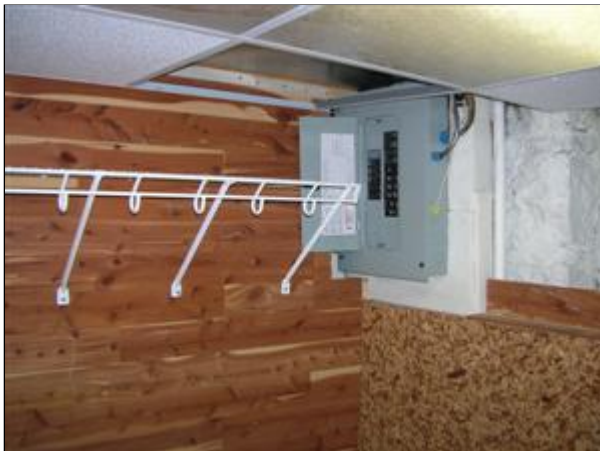
5.2 Picture 1

**5.2** The main panel has missing knock out blanks which is a safety concern due to exposed electrical connections, a condition which should be corrected. The main panel does not have thirty-six inches of clear space in front of the panel cover. This condition should be corrected by a qualified contractor.

The main panel is located in a closet which can be hazardous due to combustible materials, hangers and lack of access. This configuration is not presently allowed and you may wish to have an electrician elaborate on this concern.

The main panel has missing knock out blanks which is a safety concern due to exposed electrical connections, a condition which should be corrected. The main panel does not have thirty-six inches of clear space in front of the panel cover. This condition should be corrected by a qualified contractor.

The main panel is located in a closet which can be hazardous due to combustible materials, hangers and lack of access. This configuration is not presently allowed and you may wish to have an electrician elaborate on this concern.

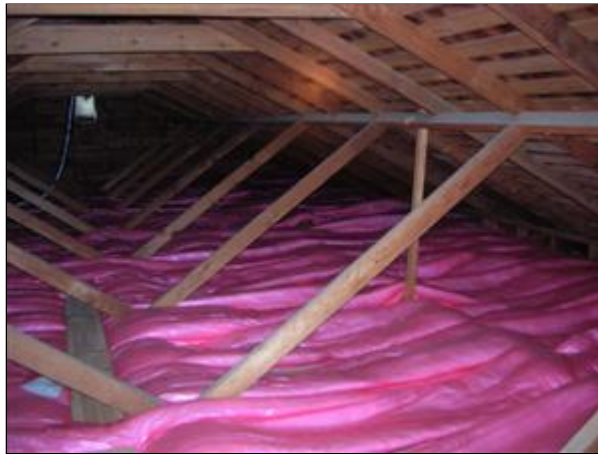
9.0 Picture 1

9.0 is about eight inches thick or just over 29 R-Value.
